Pine River-Van Etten Lake Watershed Management Plan

September 2008

Huron Pines

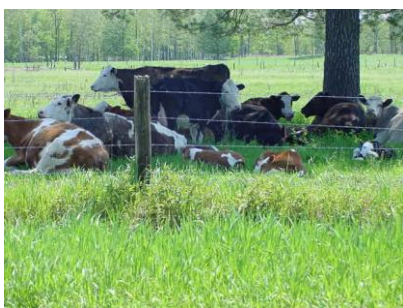
Cattle behind exclusion fencing
